INVENTORY OF MONUMENTS AT PAGAN

Volume One
Monuments 1-255

PIERRE PICHARD

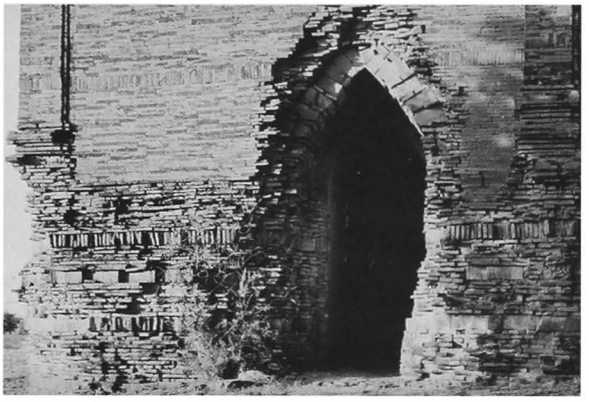
803

- no maintenance : vegetation scarcely cleared, cracks and local damage unrepaired.

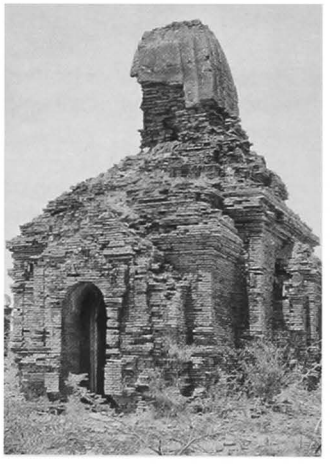
1130

- loss of facing, due to rainwater percolation and poor bonding.

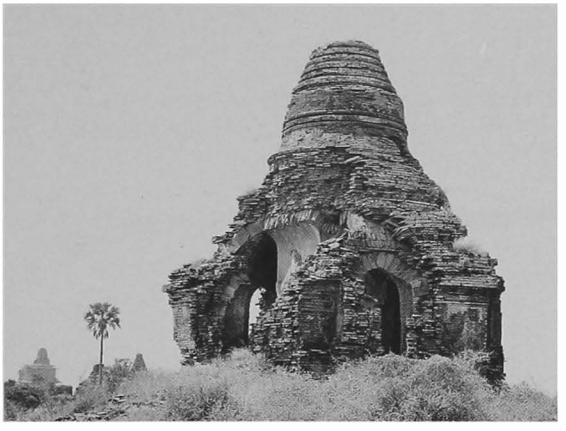
1583 **G**

- half-ruined : facing extensively disintegrated, local collapse, large cracks, etc.

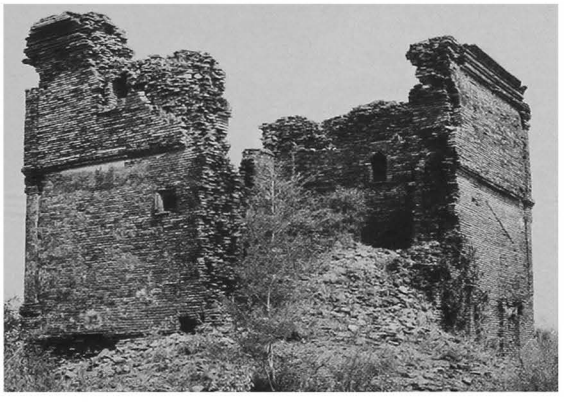
713 **H**

- ruined : upper parts collapsed, parts of wall still standing, ground floor usually buried under debris, etc.

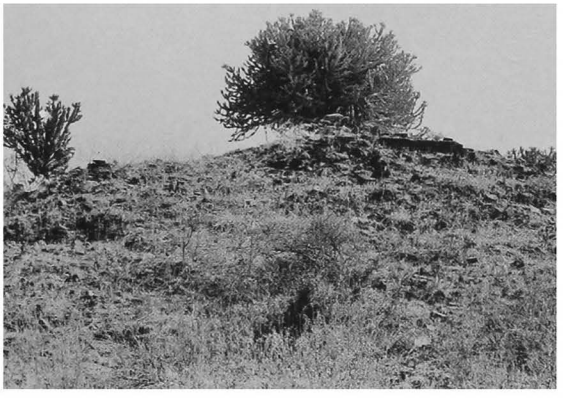
979 **J**

- unexcavated mound, ground plan untraceable.

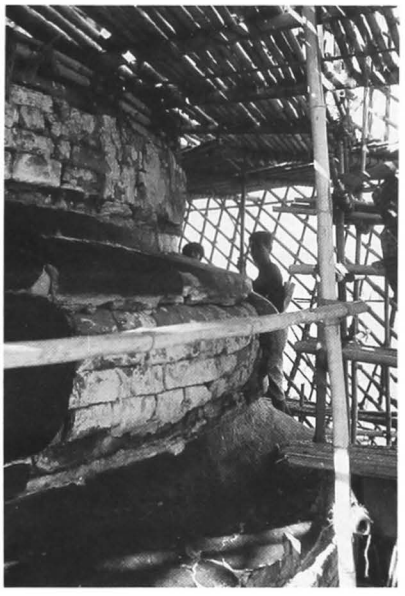
5 present condition
- regularly maintained by Trustees.
- top of dome and spire damaged by the 1975 earthquake, repaired and strengthened by Const. Corp., 1975-78.
- dome gilded 1983-84.

1 l - Spire rings after the earthquake, 1975

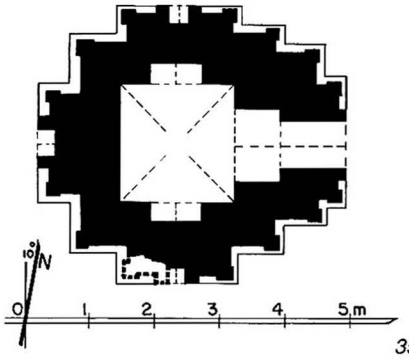
35 a - Plan

5 present condition
- ruined.
- ground floor under debris.
- upper part collapsed in the 1975 earthquake.

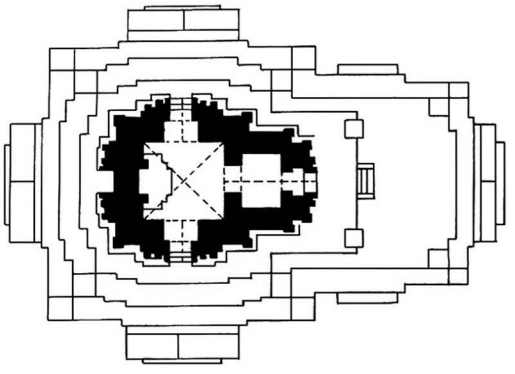
37 a1- Plan of upper-storey

5 present condition
- upper parts destroyed and upper storey seriously damaged by the 1975 earthquake.
- repaired and strengthened (Const. Corp.) 1981.
- minimal maintenance.

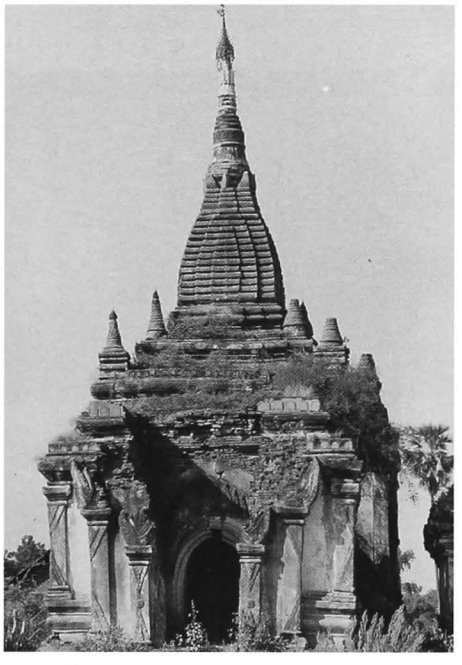
40 c - From east

5 present condition
- maintained by Trustees.
- whitewashed.
- vault on entrance hall collapsed.

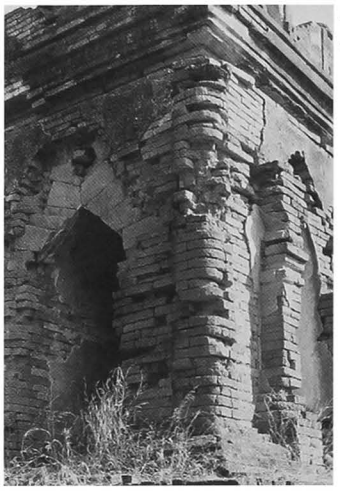
41 b - North entrance and north-west corner

5 present condition
- no maintenance.

7 decoration
exterior :
- rounded corner pilasters.
- plain stucco mouldings, still in place 40 %.

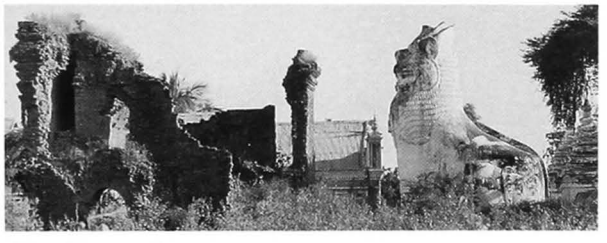
42 c - From north

5 present condition
- ruined.
- west wall, vaults and roof collapsed.
- ground floor buried under debris.

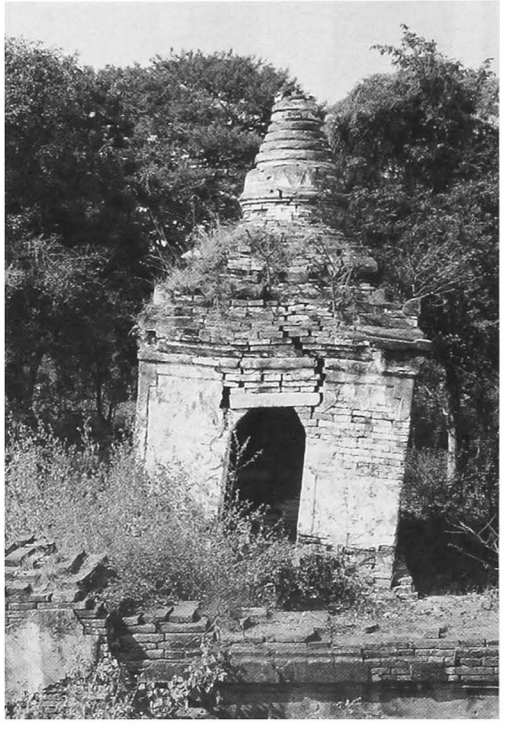
57 b - From east

5 present condition
- no maintenance.

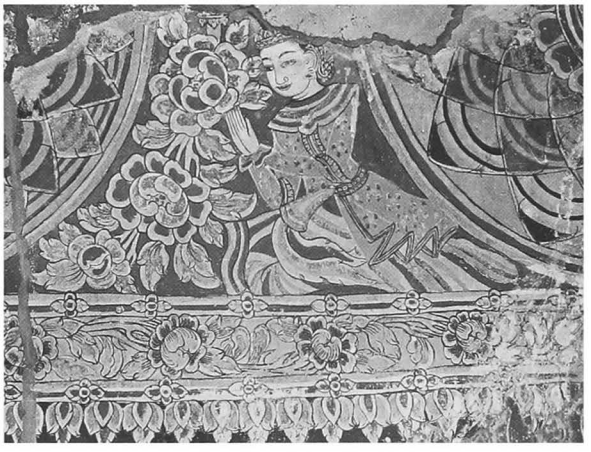
62 h - North corridor, detail of vault, on east side

5 present condition
- maintained by Trustees.
- whitewashed.
- repaired 1947.
- cracked by the 1975 earthquake.
- repaired 1976.

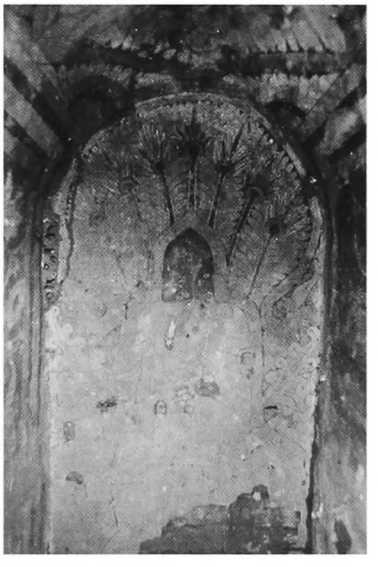
66 d - West niche

5 present condition
- half-ruined.
- no maintenance.

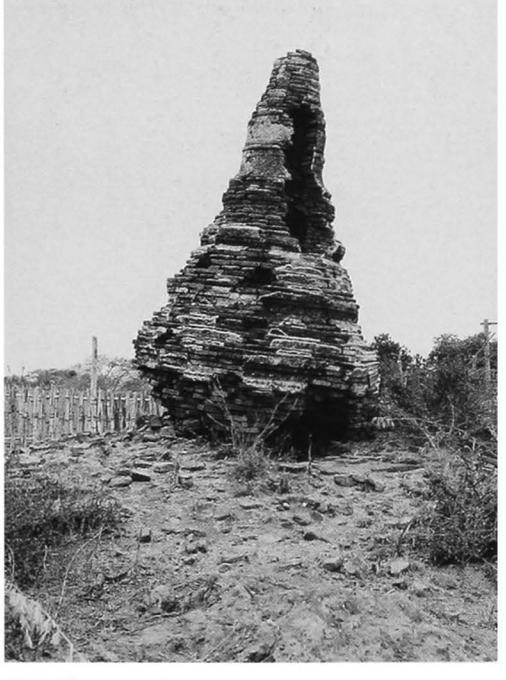
68 b - From south-east

5 present condition
- no maintenance.
- half-ruined.
- leaning to east.

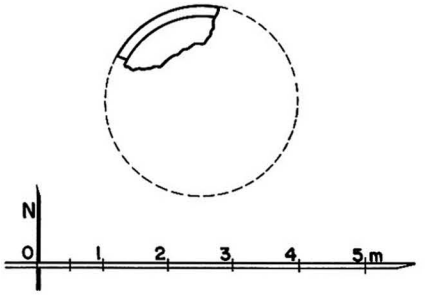
69 a - Plan

5 present condition
- ruined.
- only part of north side remains, height = 1.30 m.

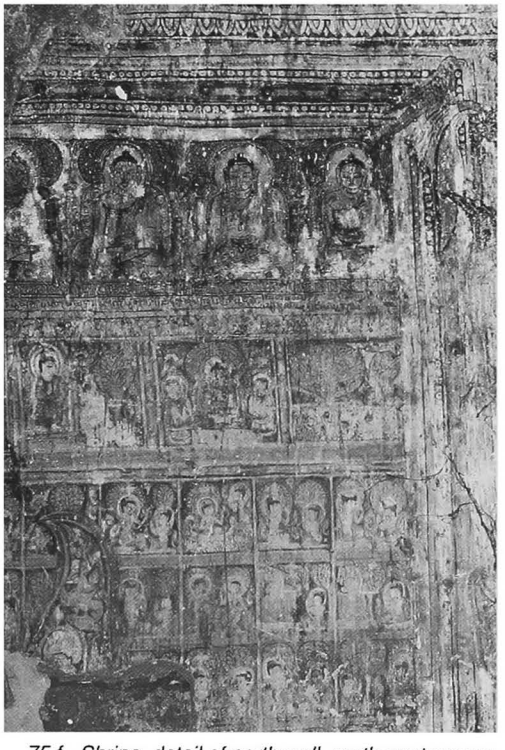
5 present condition
- minimal maintenance.

75 f - Shrine, detail of north wall, north-east corner

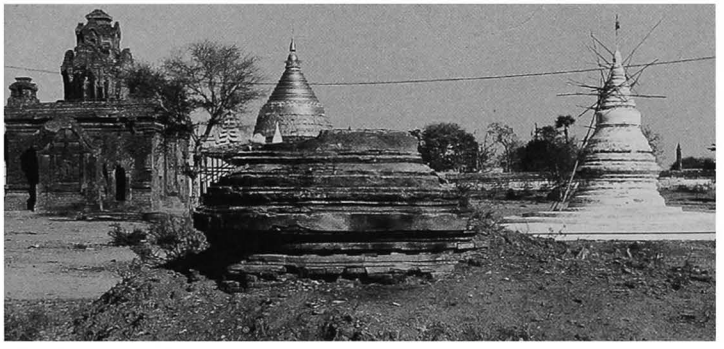
5 present condition
- previously ruined (height 1.10 m).
- rebuilt 1984.

76 c - From south (1983)

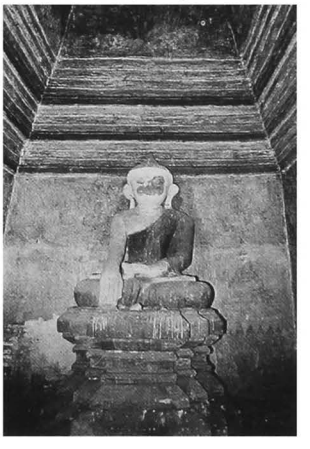
5 present condition
- half-ruined.

78 d - West face, north-west corner

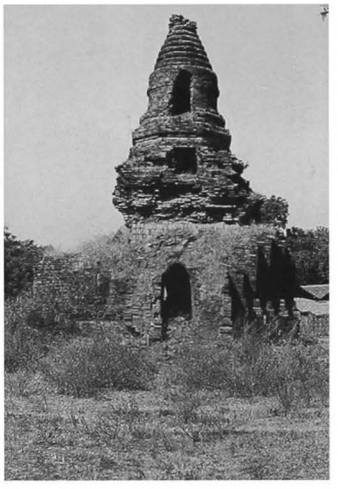
5 present condition
- half-ruined.

79 c - From east

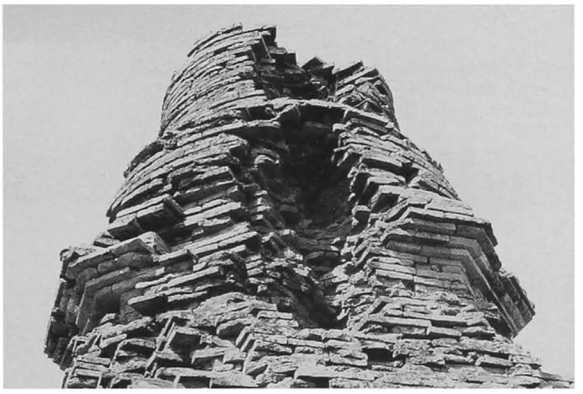
5 present condition
- half-ruined.

80 c - Upper parts, from south-east

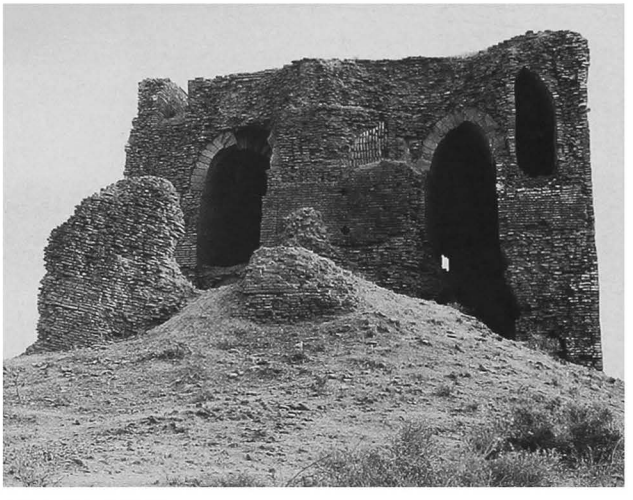
5 present condition
- ruined.
- north part collapsed.
- ground floor buried under debris.

82 f - From north

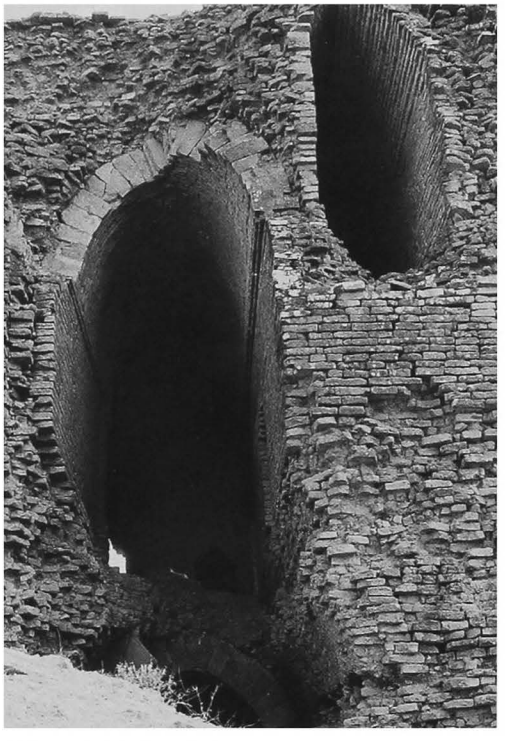
82 g - Detail of north face, north-west corner

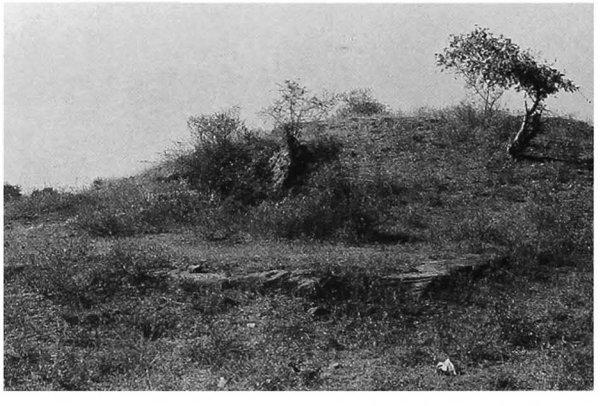
5 present condition
- ruined.
- ground floor buried under debris.

86 d - Stone plinth, from north-east

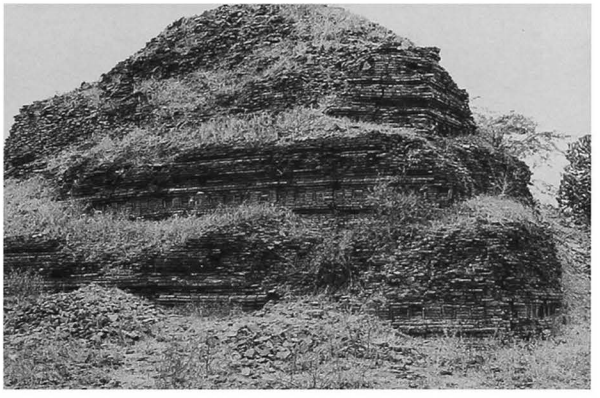
5 present condition
- ruined.

87 c - South face, south-east corner

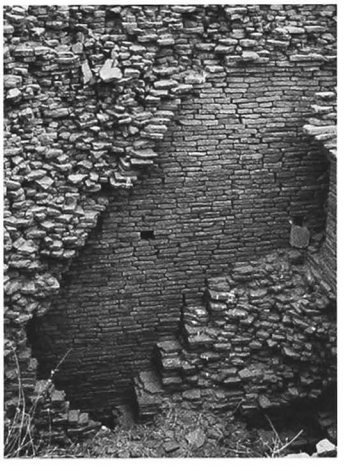
5 present condition
- half-ruined.
- vaults of upper storey and roof collapsed.

88 d - Interior, north-west staircase

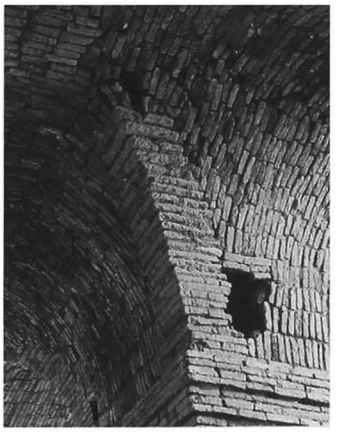
5 present condition
- half-ruined.
- vaults of upper storey and roof collapsed.

89 c - Corridor vault, north-east corner

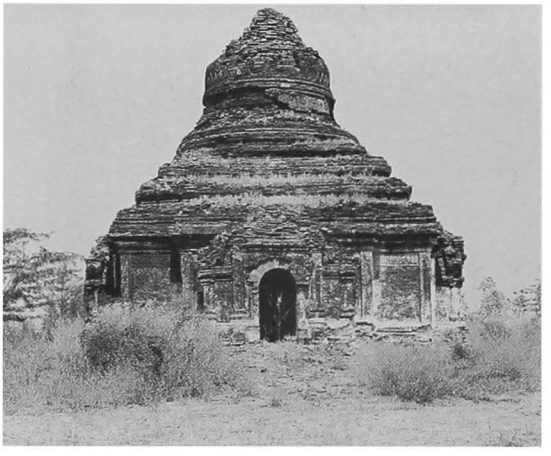
90 b - From east, together with 89 and 88

5 present condition
- no maintenance.
- upper parts damaged.
- base disintegrating.

7 decoration
exterior :
- stucco mouldings, still in place : 35 %.
- ornate cornice and pilasters.
- tasselled frieze with pointed obovals.
- pediments damaged.

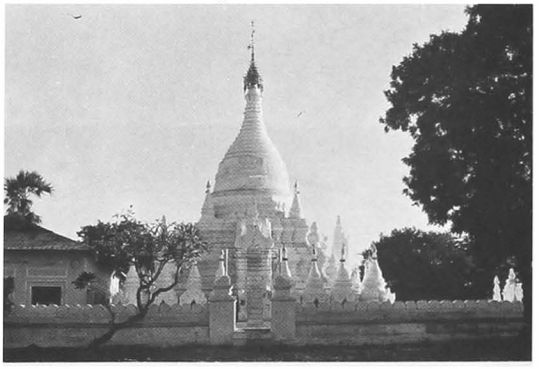
95 b - North face,1990, present condition

5 present condition
- facing of dome disintegrating.
- repaired by Trustees, 1984-88.
- whitewashed.

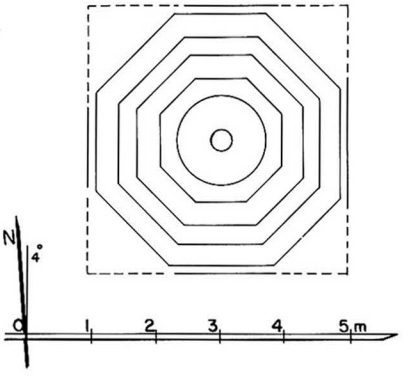
112 a - Plan

5 present condition
- no maintenance.
- spire partly destroyed.

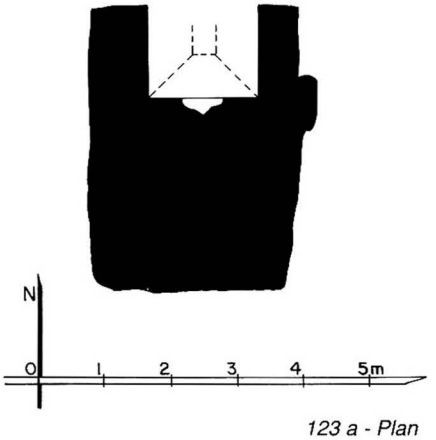
123 a - Plan

5 present condition
- no maintenance.
- half-ruined.
- base repaired (1988).

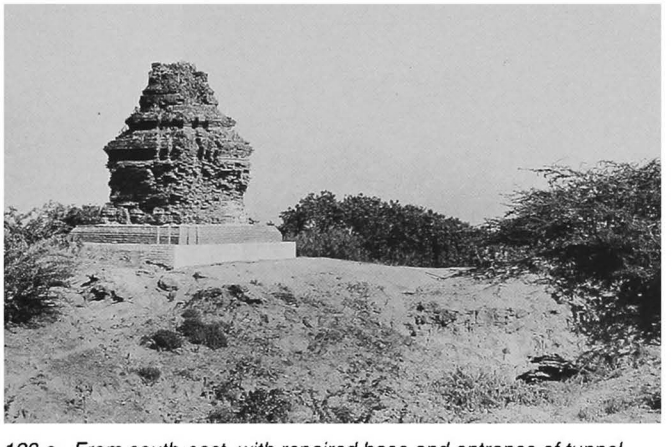
123 c - From south-east, with repaired base and entrance of tunnel

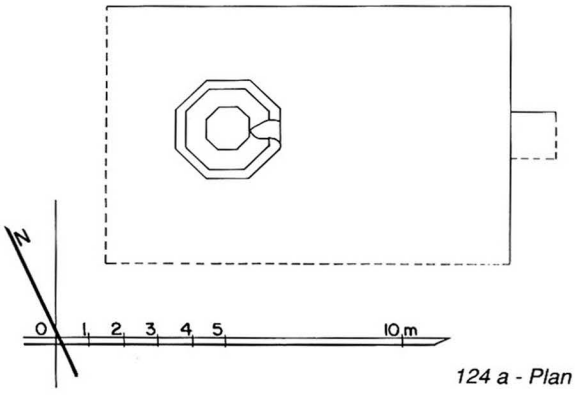
124 a - Plan

5 present condition
- ruined.

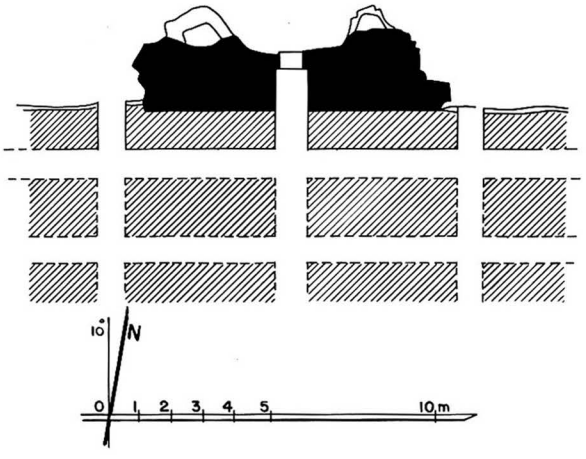
126 a - Plan

5 present condition
- ruined and unexcavated.

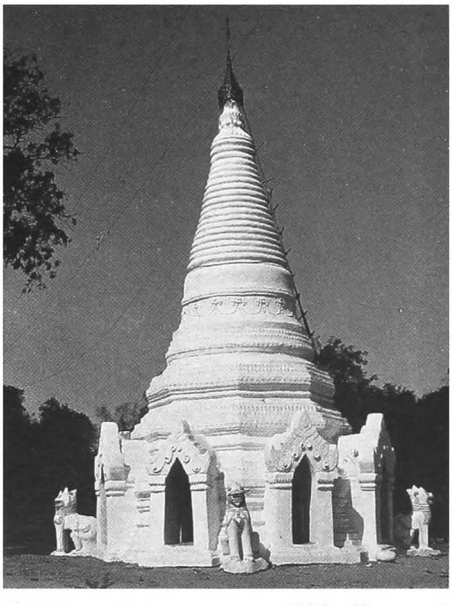
132 b - From east

5 present condition
- maintained by Trustees.
- whitewashed.

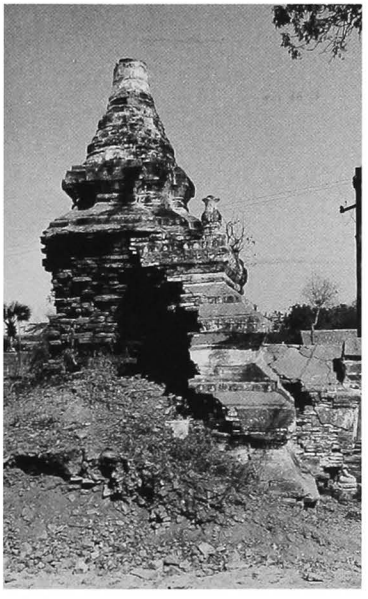
133 b - From south

5 present condition
- half ruined, only east face remains.
- partly whitewashed.

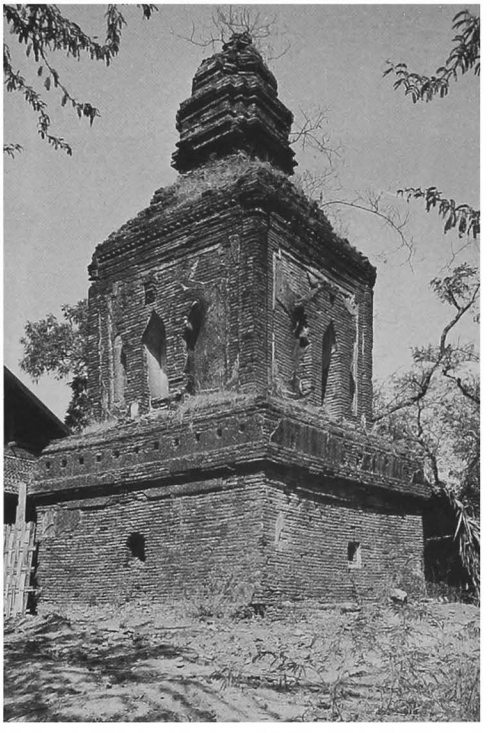
134 b - From south-east

5 present condition
- no maintenance.

7 decoration
- stucco mouldings, still in place : 10 %.

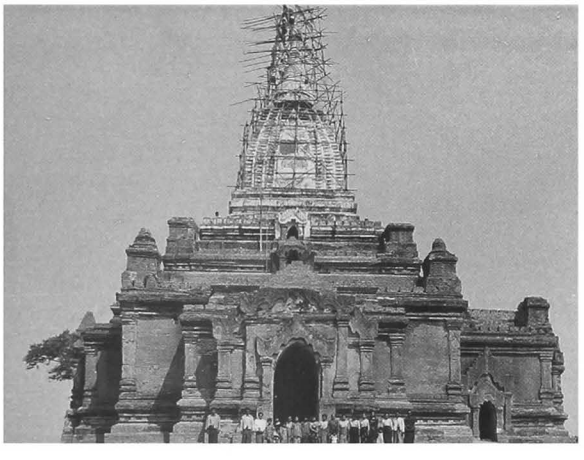
135 l - South face, 1984

5 present condition
- repaired (Const. Corp.) 1983-84.
- new umbrella provided by private donor, 1984.
- tower whitewashed.

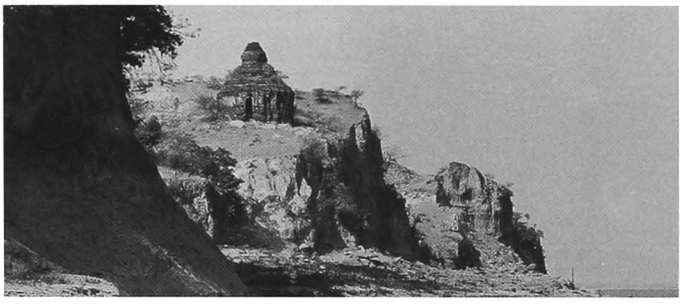
136 c - From south-west

5 present condition
- vaults and arches cracked by the 1975 earthquake.
- upper parts half-ruined.
- endangered by erosion of river bank.

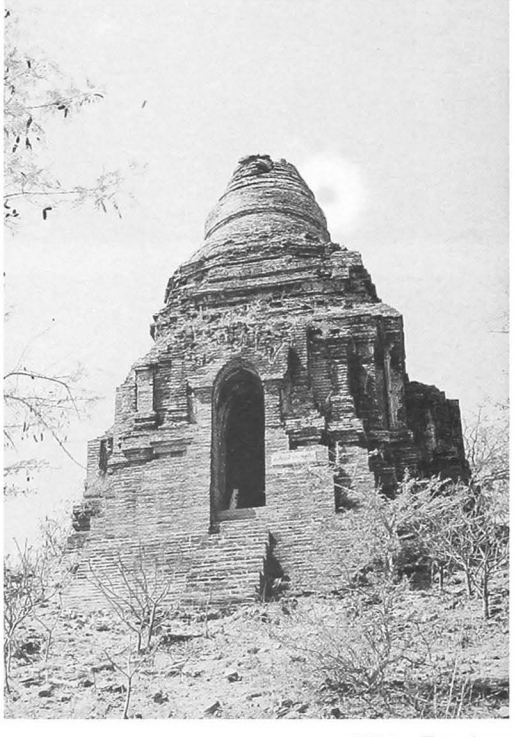
137 b - East face

5 present condition
- terraces and upper parts damaged.

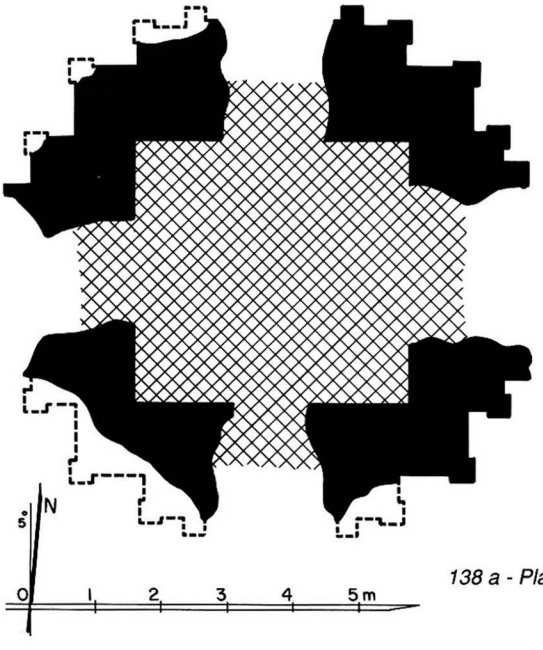
138 a - Plan

5 present condition
- ruined.
- vaults collapsed.
- ground floor buried under debris.

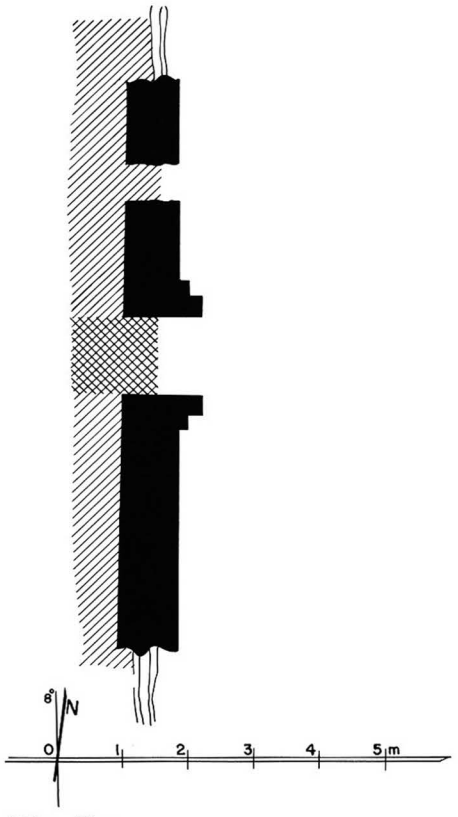
139 a - Plan

5 present condition
- ruined and unexcavated.

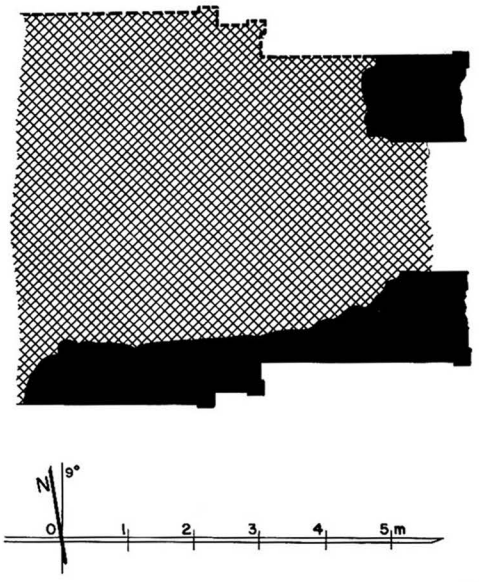
140 a - Plan

5 present condition
- ruined and half-buried.

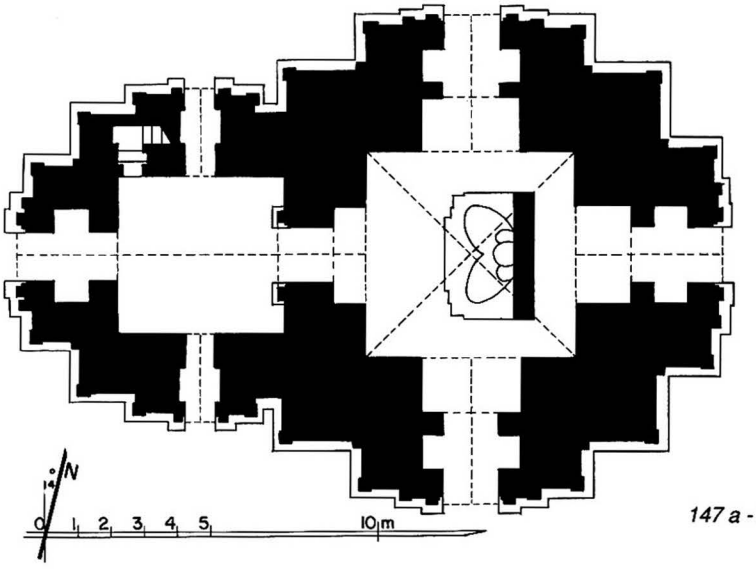
147 a - Plan

5 present condition
- regularly maintained.
- heavy loss of plaster and mural paintings during the 1975 earthquake.
- strengthened 1989 (Const. Corp.).

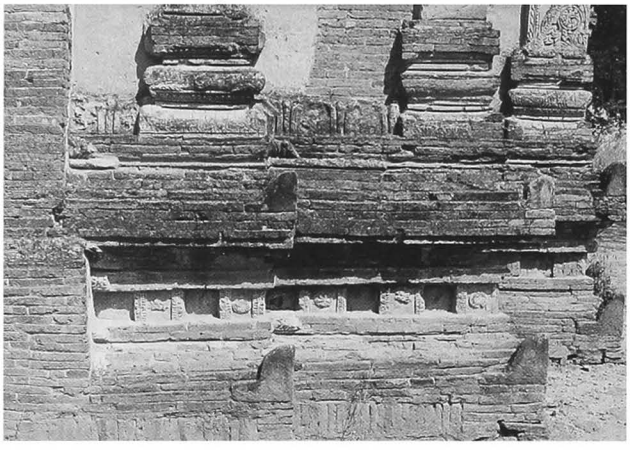
147 i - West face, west porch, south-west corner

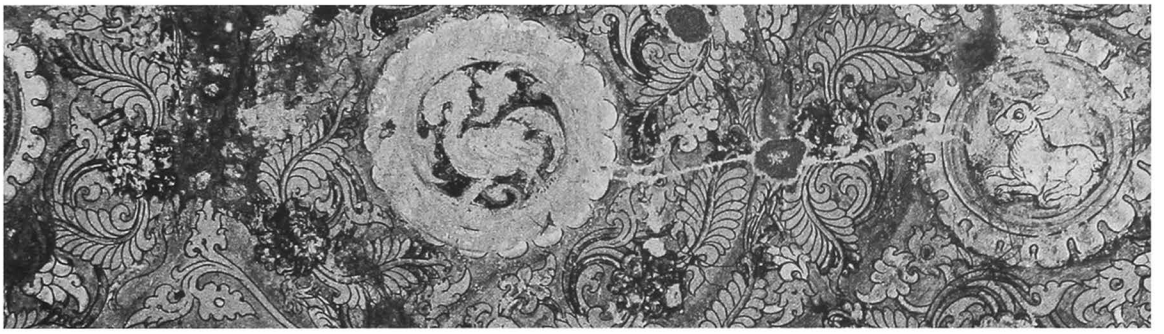
147 m - East vestibule, detail of vault

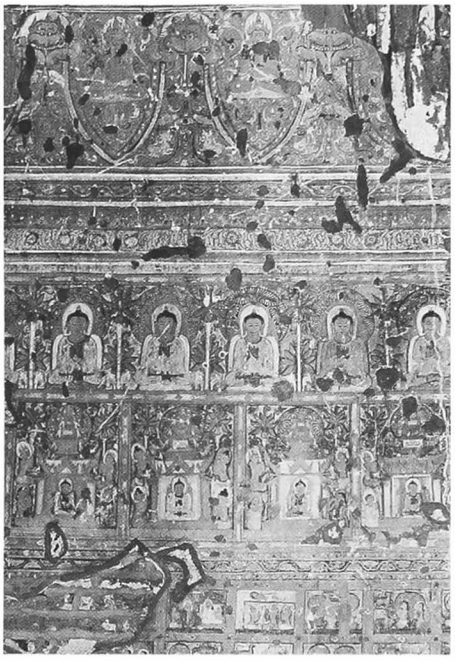
147 n - West entrance hall, south wall

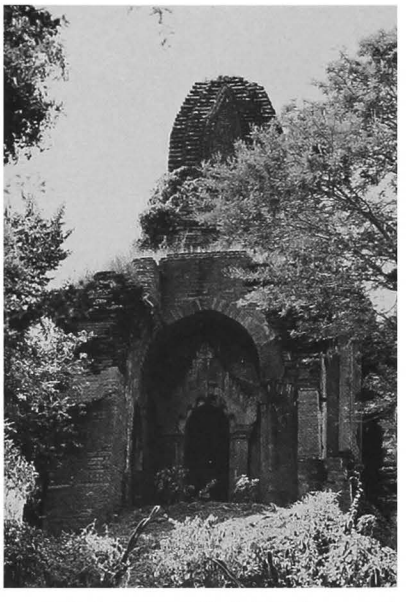
150 d - From north (1988, after repair)

5 present condition
- repaired (Dept.) 1986.

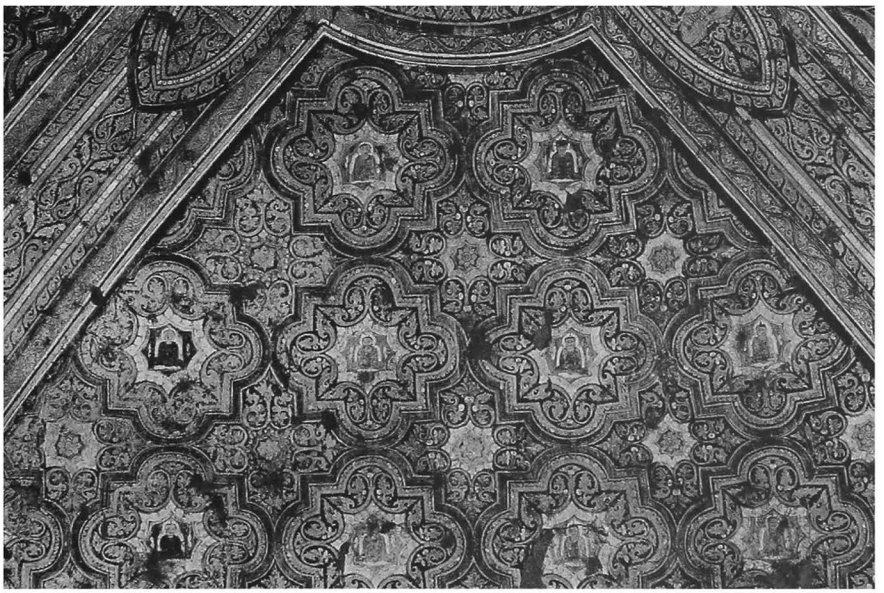
151 p - Shrine vault, detail, from north

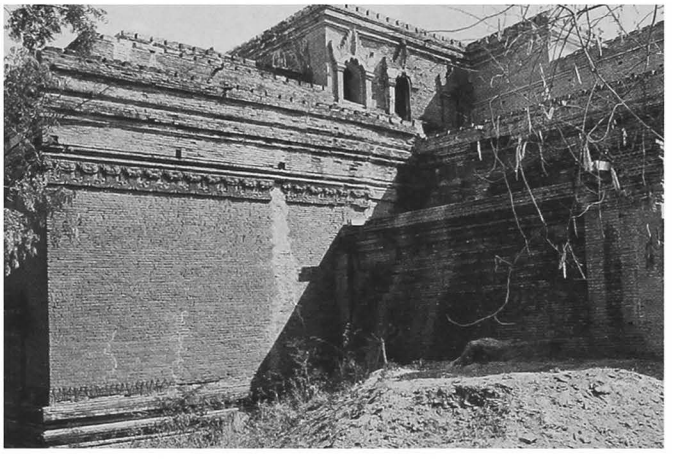
154 i - North porch, condition in 1902 (photo ASI, New Delhi)

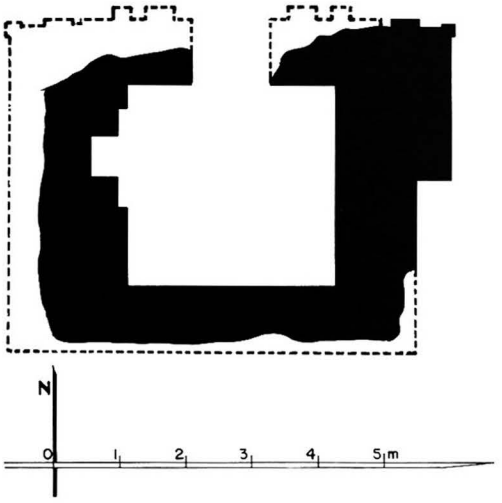
170 a - Plan

5 present condition
- ruined.

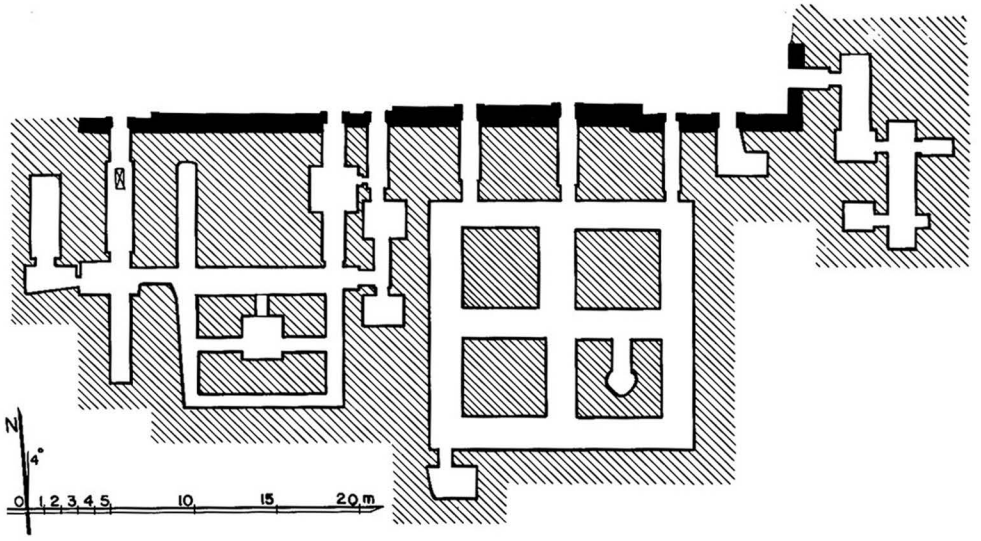
171 a - Plan

5 present condition
- regularly maintained.
- repaired and strengthened (Const. Corp.) 1981.

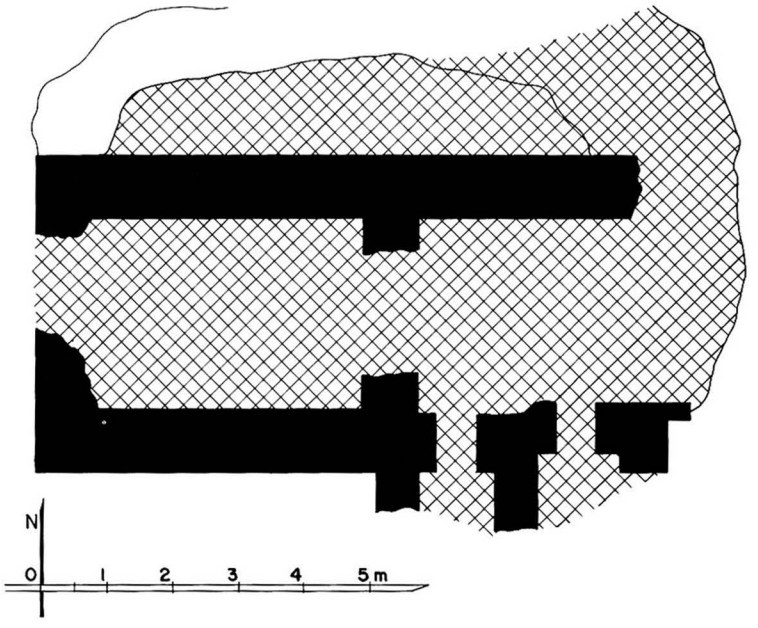
174 a - Plan

5 present condition
- ruined.
- no trace of vaults.
- ground floor buried under debris.

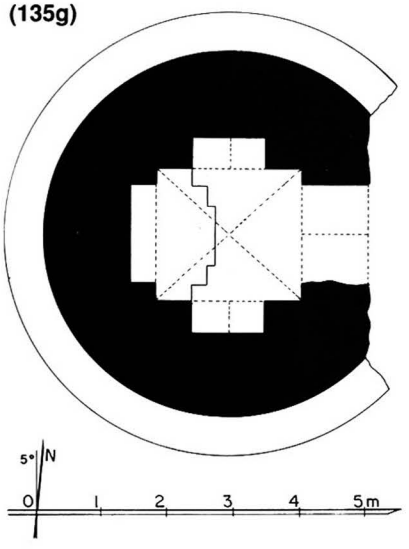
175 a - Plan

5 present condition
- half-ruined.

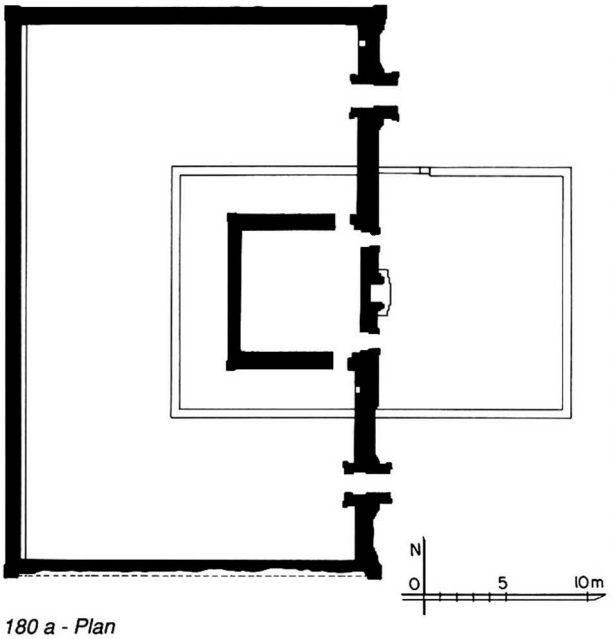
180 a - Plan

5 present condition
- repaired (Dept.) 1959.

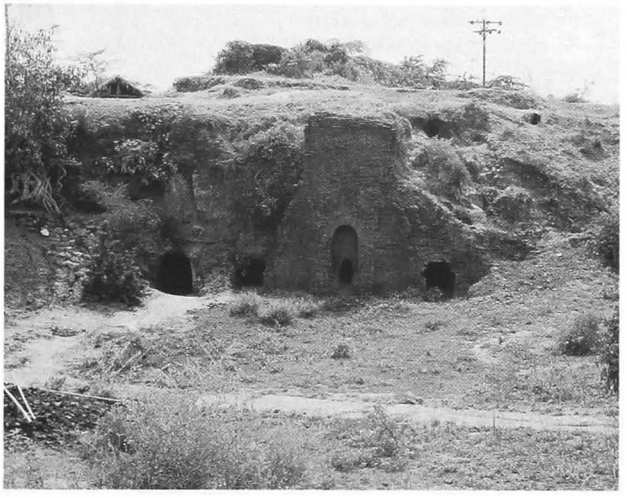
5 present condition
- half-ruined.

186 b - From north

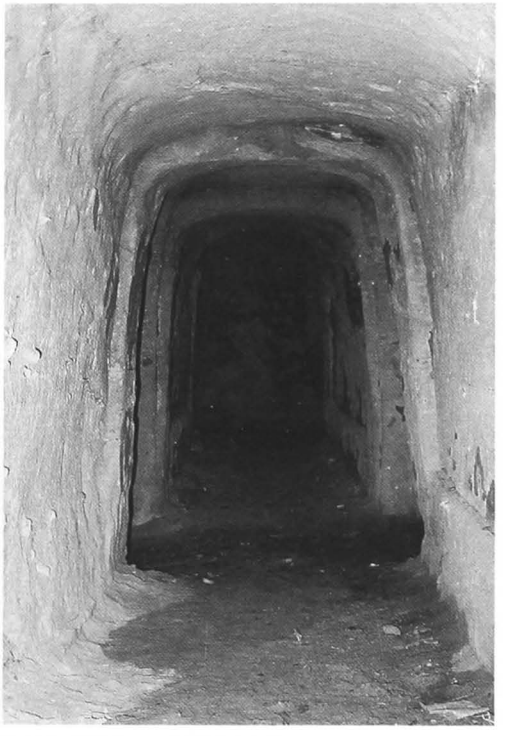
186 c - East tunnel, from north

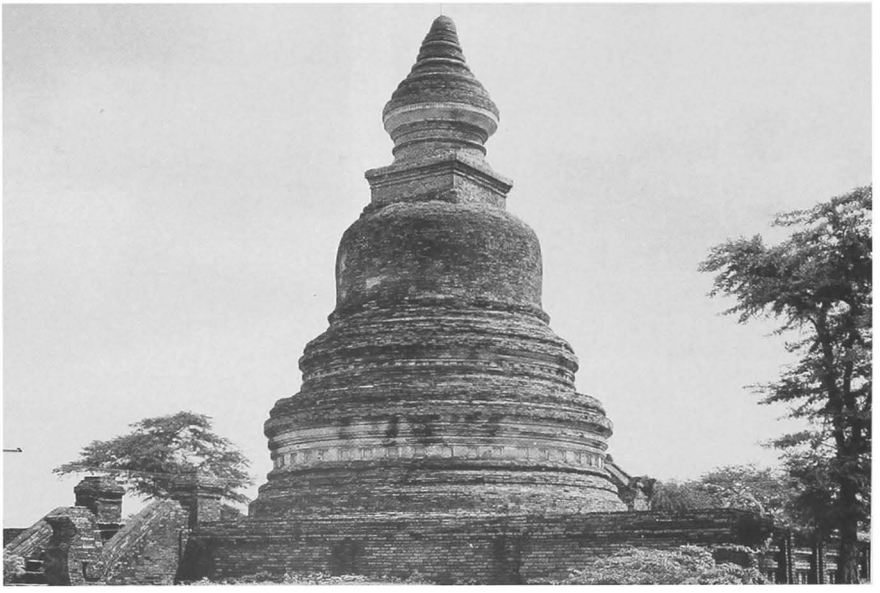
5 present condition
- regularly maintained.
- repaired.

187 b - From south (October 1983)

187 c - From north-west, in 1975

187 d - Repaired upper parts (October 1983)

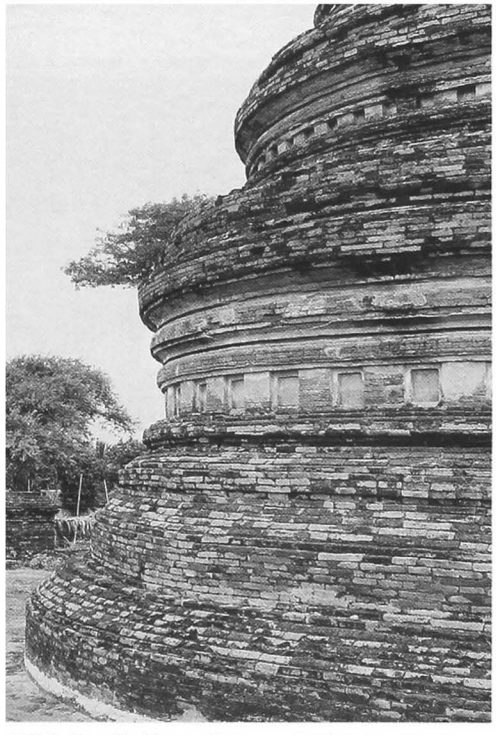
187 f - Detail of base, from south (October 1983)

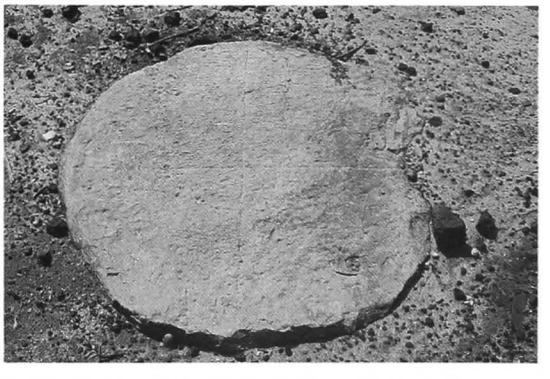
5 present condition
- ruined.
- minimal maintenance.

189 f - East vestibule, base of column, from north

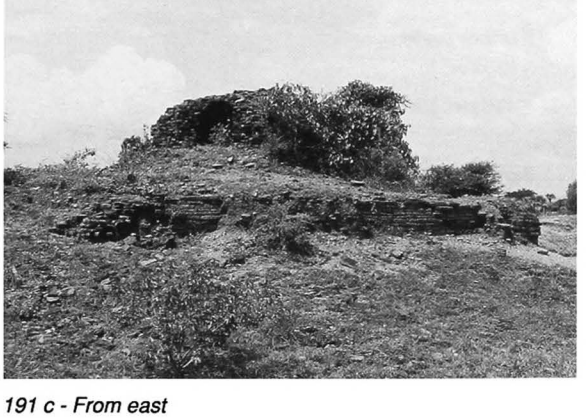
5 present condition
- ruined.

191 c - From east

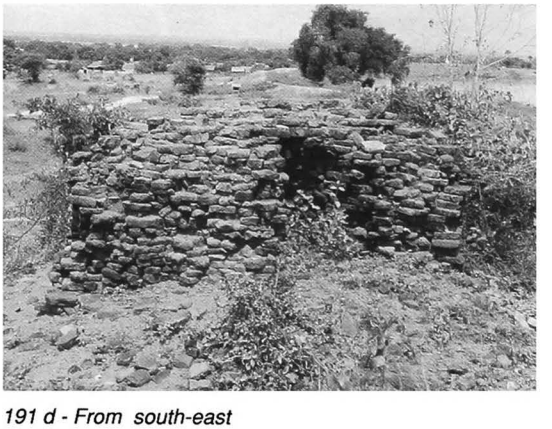
191 d - From south-east

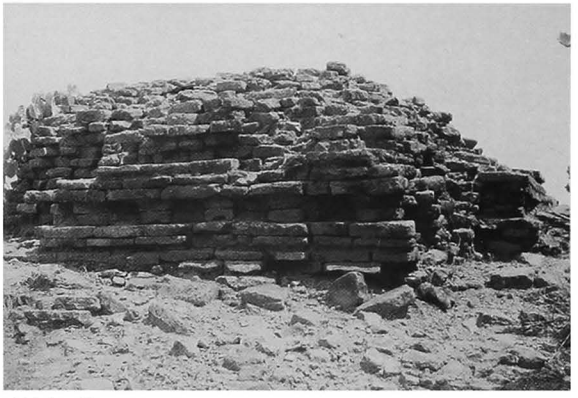
193 b - From west

5 present condition
- ruined.

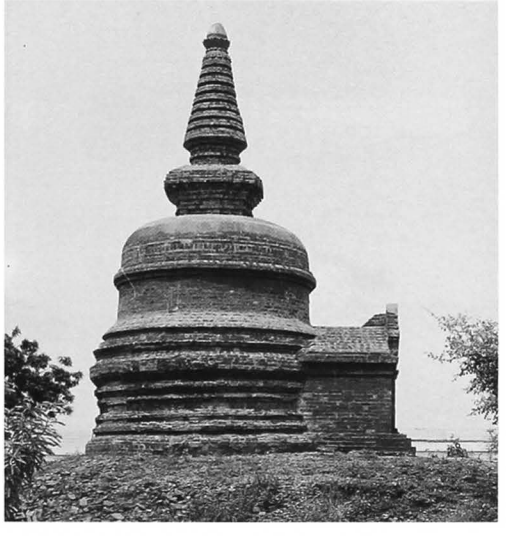
5 present condition
- formerly a ruin.
- rebuilt by M.O.C. in 1983.

194 c - South face, (rebuilt, October 1983)

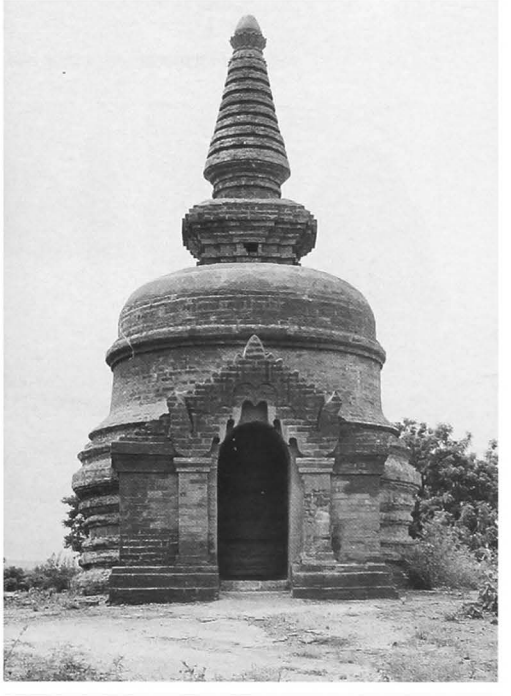
194 d - East face, (rebuilt, October 1983)

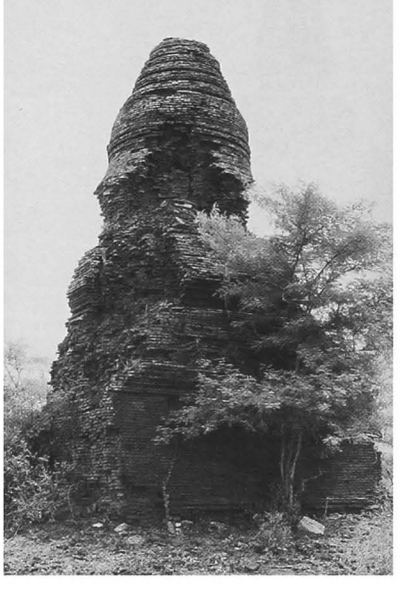
5 present condition
- half-ruined and endangered.

195 c - From north-west

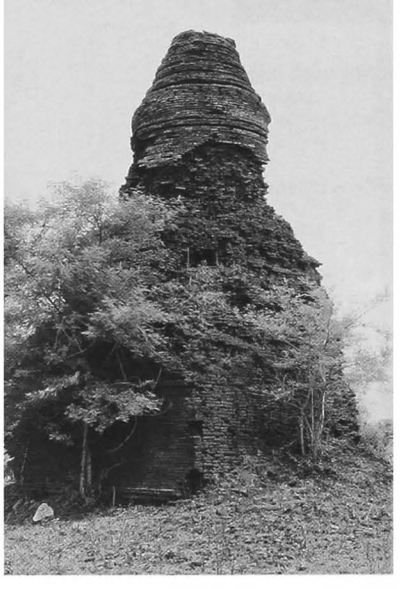
195 d - From south-west

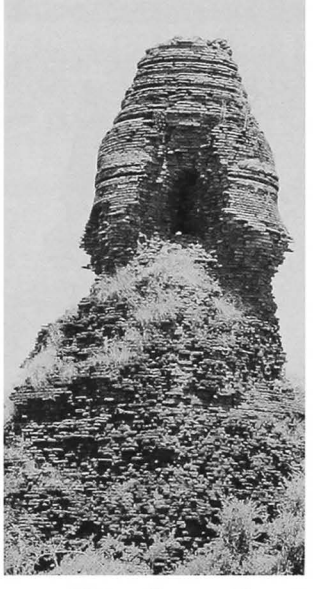
195 e - From south-east

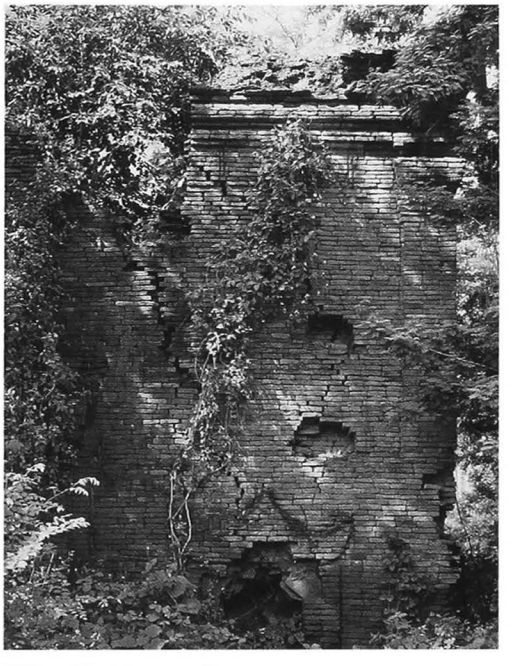
206 c - East face, north-east corner

5 present condition
- ruined.
- vaults collapsed.
- ground floor buried under debris.

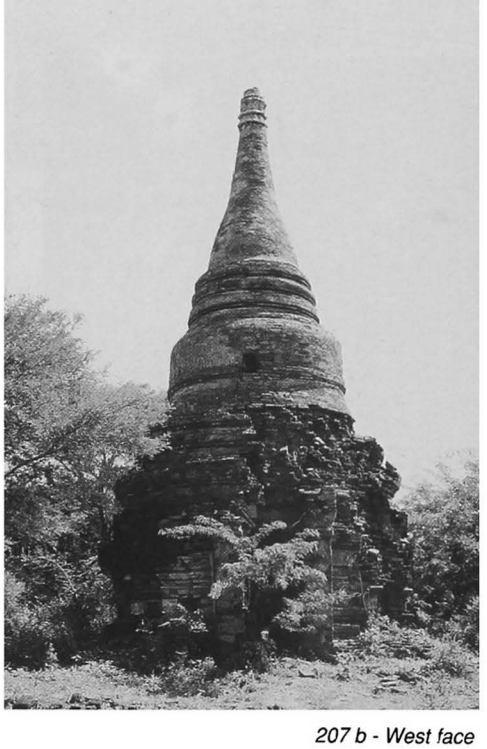
207 b - West face

5 present condition
- half-ruined.
- facing disintegrated.

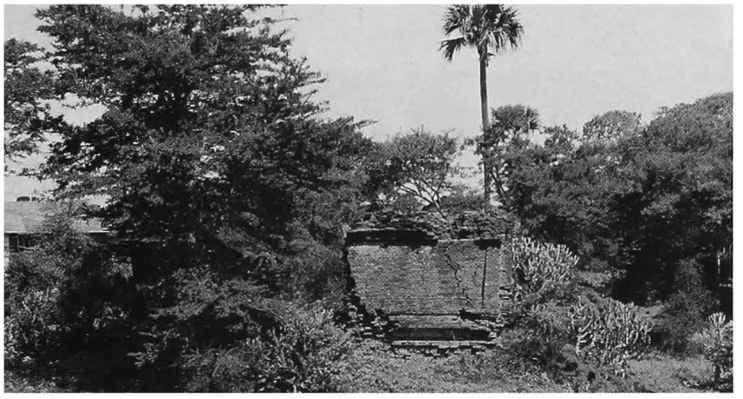
208 b - South face

5 present condition
- ruined - walls leaning outwards.
- no more trace of vaults.
- ground floor buried under debris.

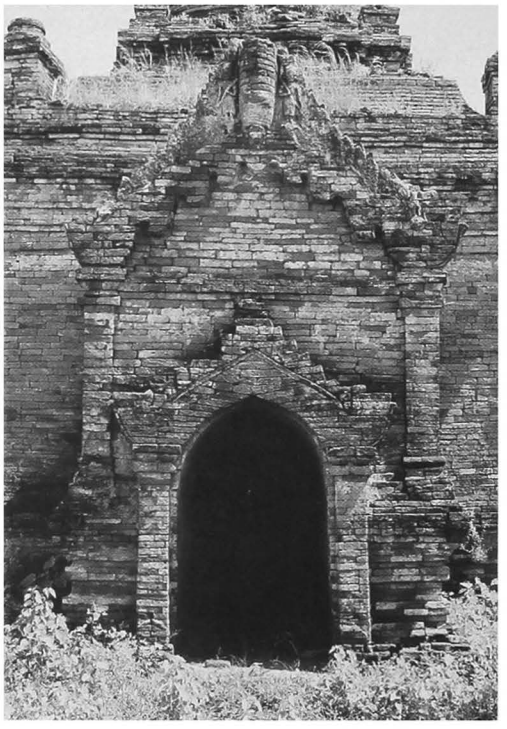
213 e - South-east corner stupa, rotated by the 1975 earthquake

5 present condition
- no maintenance.
- added foreparts detached from the main body.
- corner stupas rotated by the 1975 earthquake.

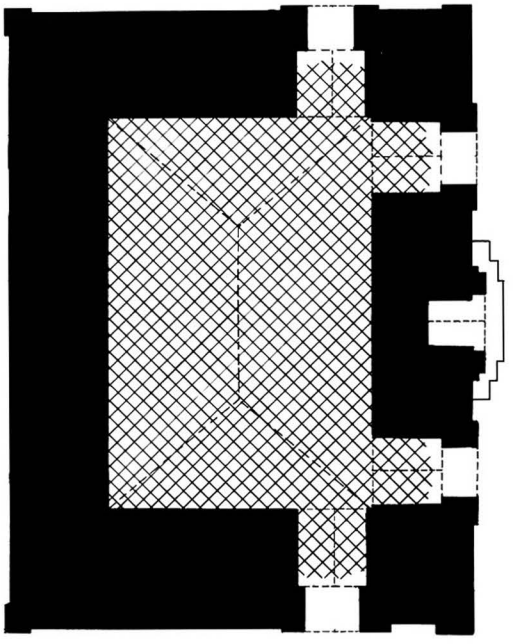
214 a - Plan

5 present condition
- half-ruined.
- vaults collapsed.
- ground floor buried under debris.

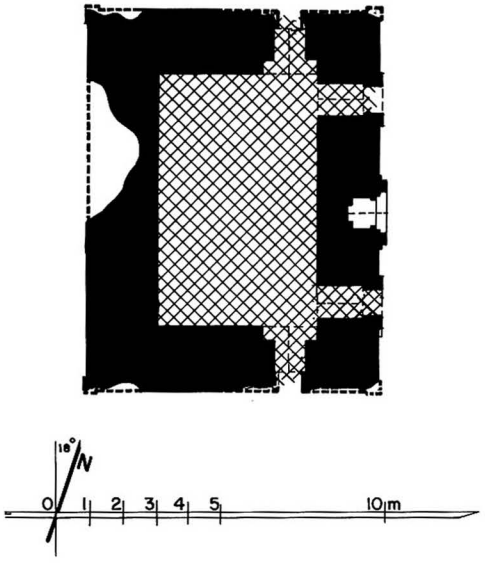
215 a - Plan

5 present condition
- ruined.
- no more trace of vaults.
- ground floor buried under debris.

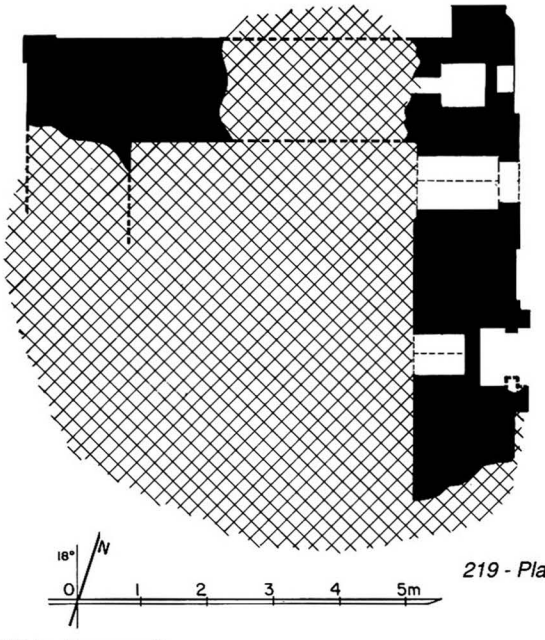
219 - Plan

5 present condition
- ruined.
- no more trace of vaults.
- ground floor buried under debris.
- west and south walls collapsed.
